Manhole Inspection Summary

Manhole # S71K__013MH

Insp Date: 1/30/08 11:42 AM

Location Address: **6800 O'Donnell St.**

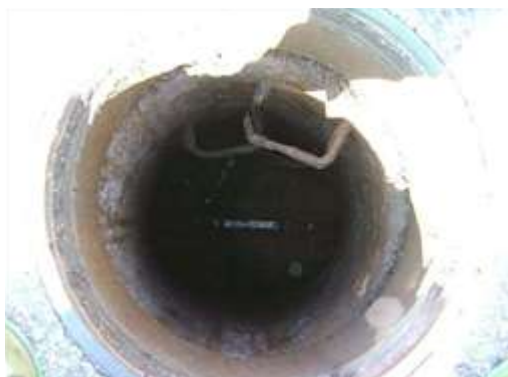
Defect 1

frame offset defect 1 in.

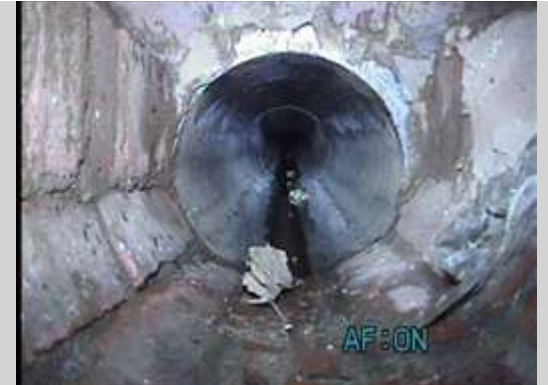
12 O'Clock Outflow

8 in. Circular Gravity Sewer
Pipe Out @ 12 O'Clock

Pipe Height: **8.4** (in.) Rod and Bar (Angled)
Pipe Material: **Clay** ☐ Pipe Lined
Invert Depth: **9.38** (ft.) Flow Characteristics: **Slow**
Deposits: ☒ None ☐ Mud ☐ Sludge ☐ Debris ☐ Grease
Silt Depth: (in.) Deposits Extent:
Infiltration: **None** Pipe Seal Cond: **Sound**

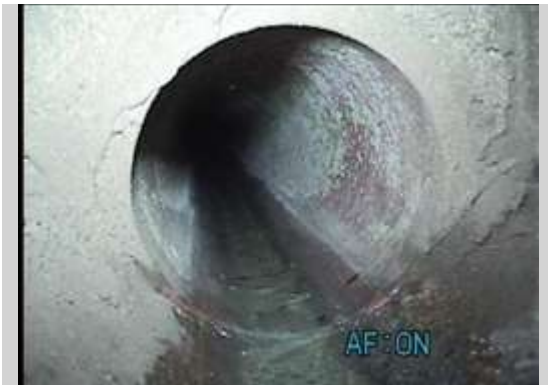
3 O'Clock Inflow

6 in. Circular Gravity Sewer
Pipe In @ 3 O'Clock

Pipe Height: **6** (in.) Rod and Bar (Angled)
Pipe Material: **Clay** ☐ Pipe Lined
Invert Depth: **8.83** (ft.) Flow Characteristics: **None**
Deposits: ☐ None ☐ Mud ☒ Sludge ☒ Debris ☐ Grease
Silt Depth: **0.5** (in.) Deposits Extent: **Medium**
Infiltration: **None** Pipe Seal Cond: **Sound**

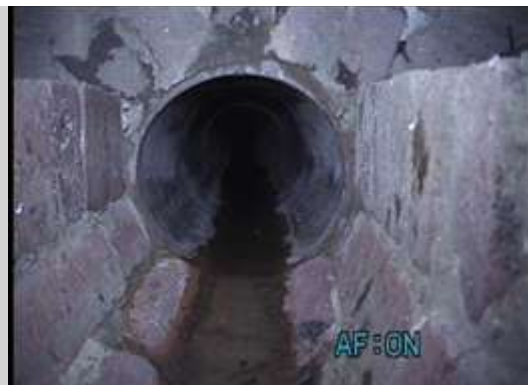
6 O'Clock Inflow

8 in. Circular Gravity Sewer
Pipe In @ 6 O'Clock

Deposits: ☒ None ☐ Mud ☐ Sludge ☐ Debris ☐ Grease

Infiltration: **None** Pipe Seal Cond: **Sound**
